COLLIERSVILLE DAM

OTSEGO COUNTY, NEW YORK
INVENTORY NO. 685

PHASE I INSPECTION REPORT NATIONAL DAM SAFETY PROGRAM

JULY 26, 1978

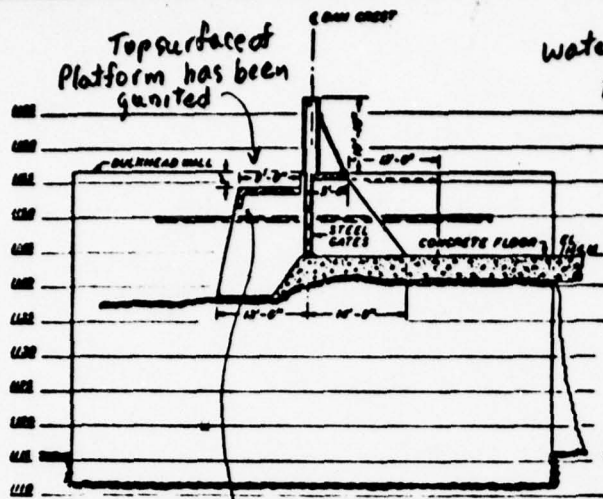
SECTION C-C

high water does contact bottom of $\frac{1}{4}$ s lip - some erosion has resulted

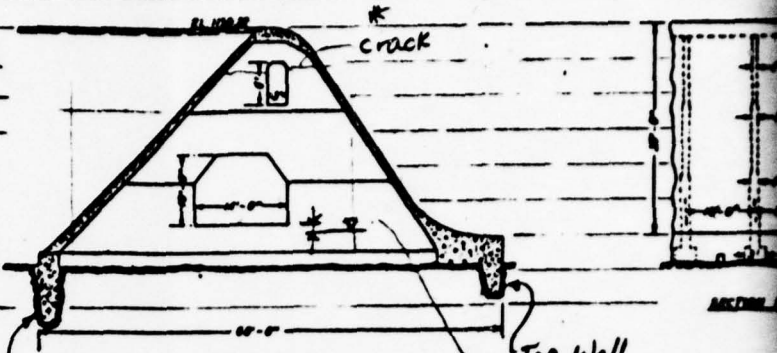
SECTION D-D

* gages monitor up and down motion of cracks since March 28, 1952

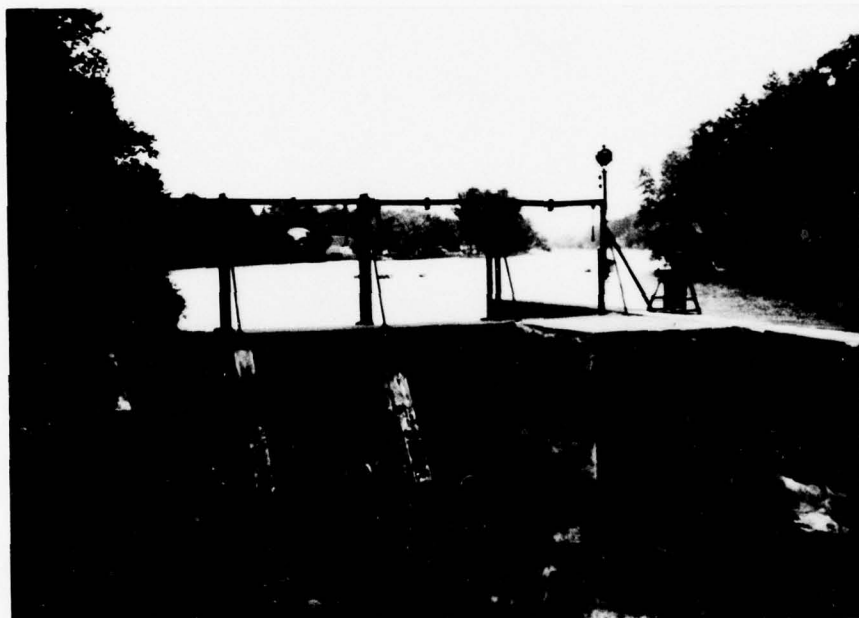
All gates and the hoist frame over the gates showed signs of rust. In addition, the segment of the hoist frame over Gate No. 3 was bent down about 2 inches in the middle.

DOWNSTREAM VIEW OF HEAD GATE STRUCTURE
ADJACENT TO RIGHT ABUTMENT

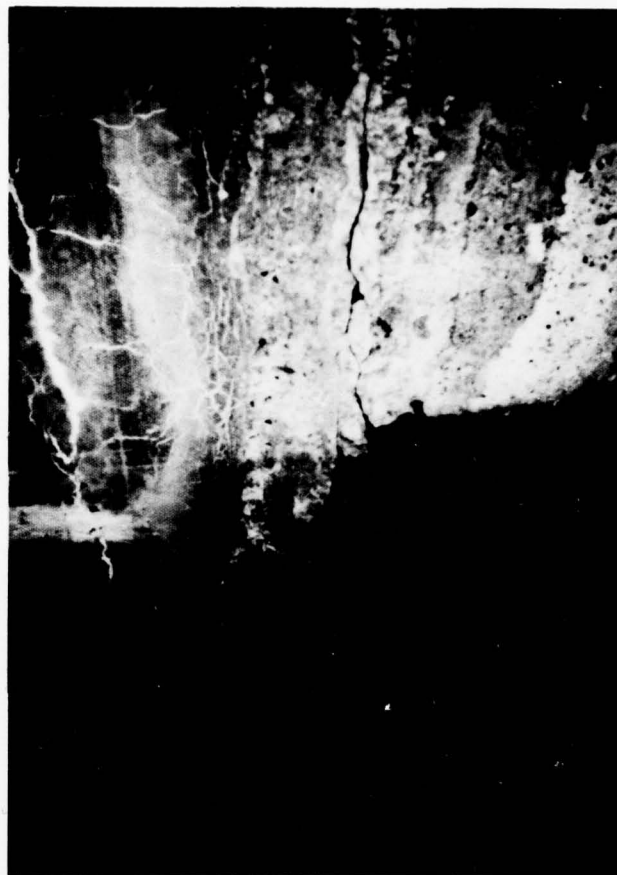
The inspection indicated bottom leakage on the left side of Gate No. 2, the second from the west. Significant leakage also was observed around the Gate No. 4 guide immediately adjacent to the dam and about 3.5 feet above the floor of the flume. There is a large area of spalled concrete adjacent to the leak. From this spalled area, a bulge in the wall which ranges from 6 to 12 inches in width extends horizontally for several feet.

The west wall of Gate Bay No. 4 had a crack 3-feet long on its downstream face about 4 1/2 feet from the floor which also continued around the downstream end. There is some spalling of the concrete on the faces of the piers of Gate Bays Nos. 2 and 3. In Gate Bay No. 1, the west wall, adjacent to the road, has some relatively long irregular cracks near the top. There is also a bulging of the upper wall a few feet downstream of the gate.

DOWNSTREAM VIEW OF NO. 4 GATE SLOT AREA
SHOWING DAMAGED WALL ADJACENT TO ABUTMENT

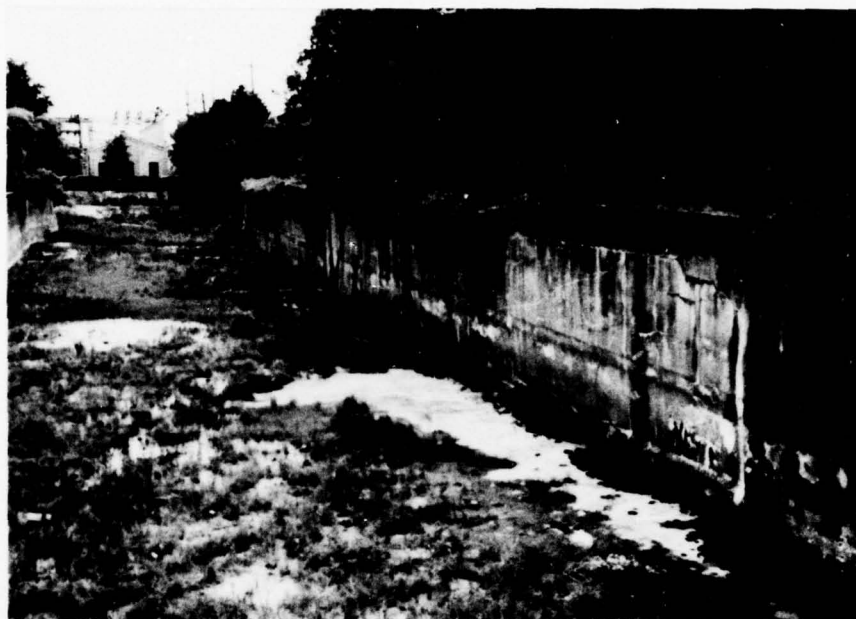
In general the condition of the headrace flume is poor. There is evidence of extensive gunite repairs to the concrete flume which was reconstructed following the collapse of the original flume. The gunite itself can now be observed to be cracked and pulling away from the concrete wall as much as 12 to 18 inches at several locations. At one location, where a highway culvert discharges water down to the flume, it appears that freezing and thawing of water in an initial crack in the gunite forced the gunite farther away from the wall to which it was applied. This condition was noted in a previous inspection report. The downstream wall of the flume near the powerhouse also shows signs of deterioration in the form of cracks, bulging and spalling of the concrete wall. In addition the buttresses stiffening the downstream wall exhibit signs of deterioration in the form of spalled surfaces, surface cracks and some areas with exposed aggregate. The ice spillway at the downstream end of the flume has been removed and the opening in the wall has been closed.

HEAD RACE VIEWED FROM HEAD GATE PLATFORM,
SHOWING IRREGULARITIES IN RIGHT WALL

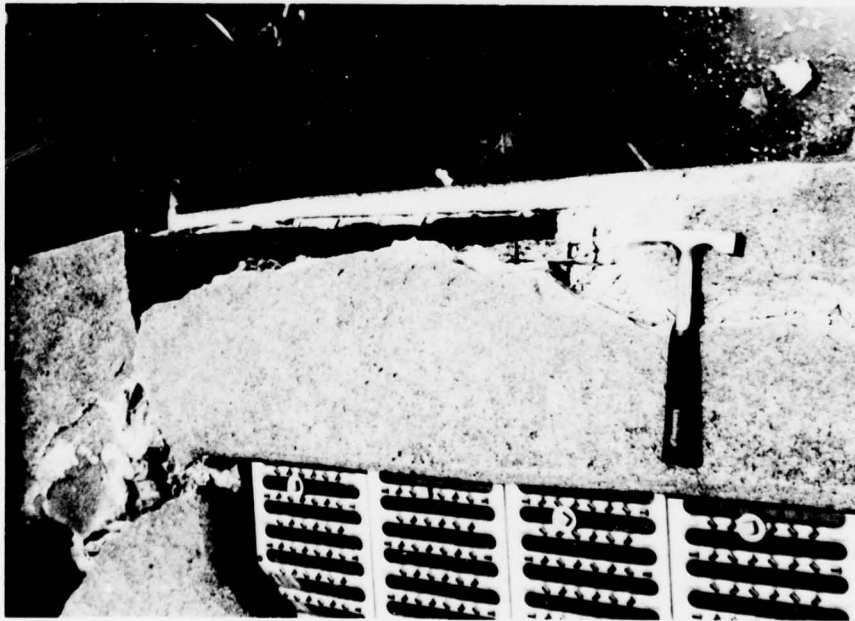
CRACK AND SEPARATION OF GUNITE SURFACE AT
JUNCTION OF RIGHT END OF DAM AND LEFT WALL
OF HEAD RACE

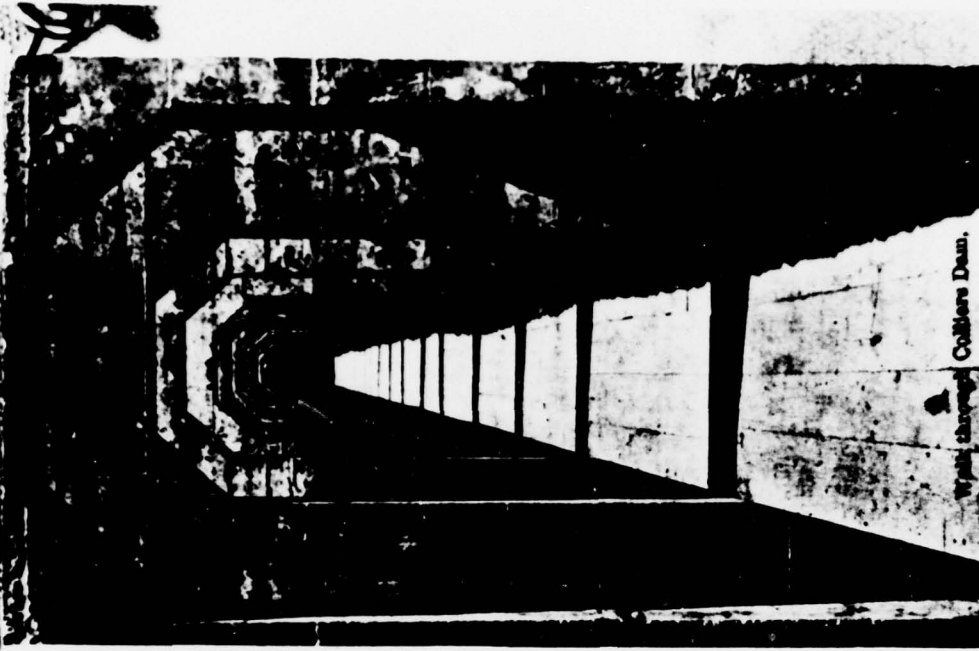
WALKWAY THROUGH BUTTRESSES BEFORE
CONSTRUCTION OF CREST SLAB

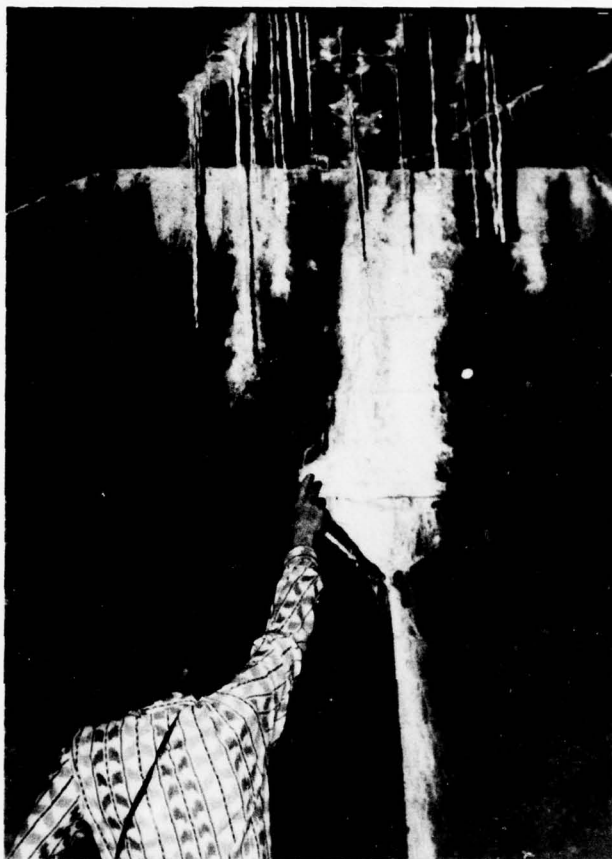
There is evidence of leakage in almost all bays. The wooden walkway between the buttresses was wet throughout and a buildup of mineral deposits was encountered at several locations. A flow of water was observed at the deteriorated portion of the left abutment wall mentioned above and another small stream of water was observed passing through the upstream face slab in Bay 9. Flow in this bay increased significantly when the head on the dam increased due to the rain previously mentioned. The cracks in Bays 4, 8, 12, 18 and 19, which are referred to above, show seepage in the form of dampness. Seepage also was observed to occur at the juncture of the upstream face slab and the buttress in some bays.

WALKWAY OPENING IN BUTTRESS,
SHOWING STALACTITES AND WALL DEPOSITS

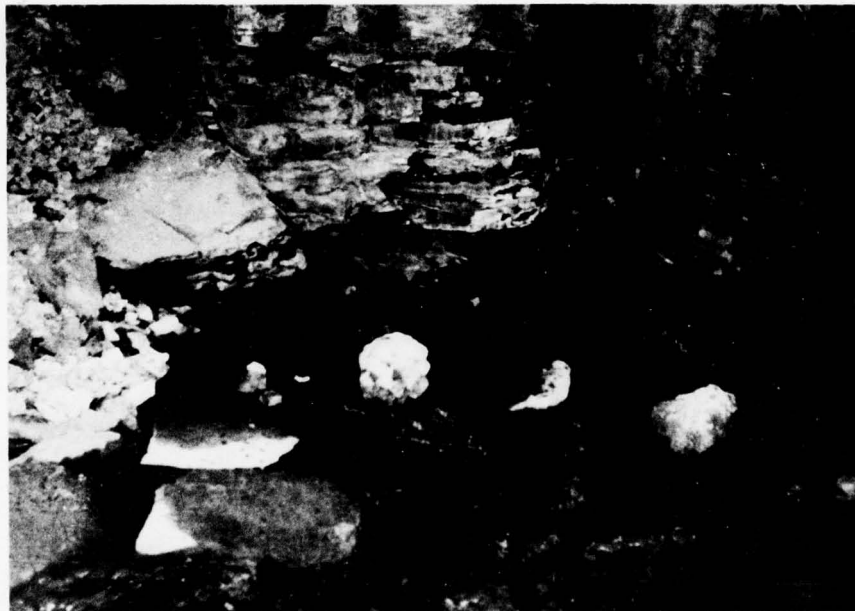
SEEPAGE AND DISCOLORATION AT LEDGE
UNDER UPSTREAM END OF HEAD RACE
